## Environmental Management of the Coastal Boundary: Sustainable Solutions for the Green Area Deficit in Manta

Joel Ricardo Alvia Fiallos<sup>1</sup>

Cite as: Alvia Fiallos JR, San Andrés-Zevallos G. Environmental Management of the Coastal Boundary: Sustainable Solutions for the Green Area Deficit in Manta. Land and Architecture. 2025; 4:221. <https://doi.org/10.56294/la2025221>

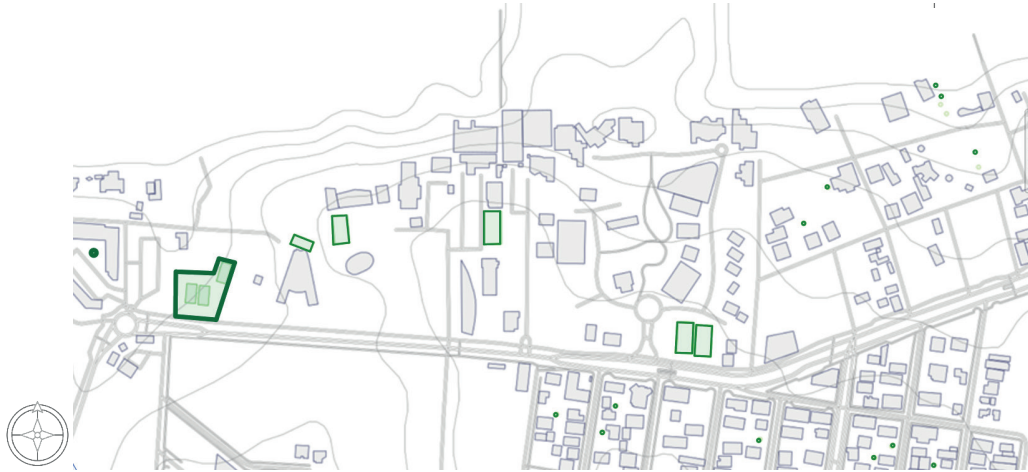
From a qualitative perspective, records made between April 14 and 18, 2025 revealed visible signs of environmental deterioration. High levels of pollution, progressive loss of native vegetation, accumulation of solid waste, soil erosion, and a decline in local wildlife were documented. In the Barbasquillo sector, for example, a pattern of disorganized urbanization and absence of natural buffer zones was observed, which affected both the ecological environment and community well-being (figure 2).

Figure 2. Visualization of the deficit of green areas in the Barbasquillo sector

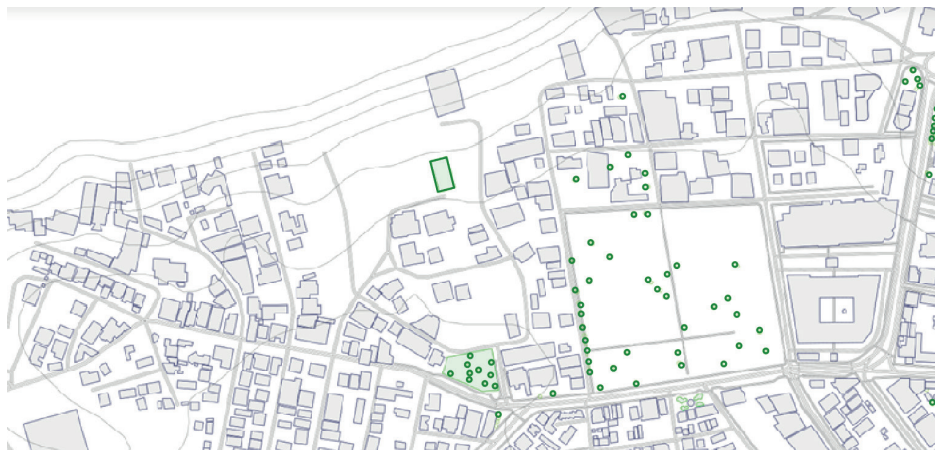
1. Uncontrolled urbanization: the main trigger for deterioration, due to an expansion model based on tourist and commercial infrastructure without sustainability criteria. In Flavio Reyes, intense land occupation with little vegetation and a clear disconnect between the urban fabric and the coastal ecosystem were identified (figure 3).

Figure 3. Visualization of the green space deficit in the Flavio Reyes sector

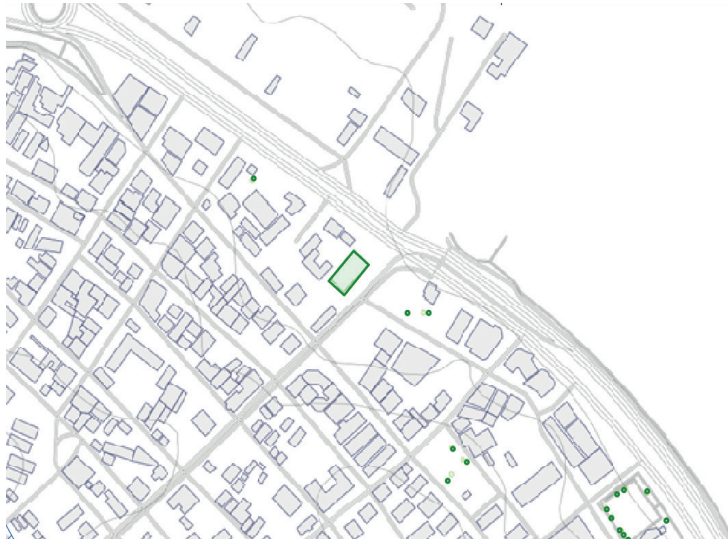
2. Environmental pollution: the second critical factor, with levels of impact ranging from 40 % to 60 % depending on the sector analyzed. An accumulation of solid waste was observed in beach areas, irregular sewage discharges, and the presence of microplastics in recreational areas, which aggravated environmental degradation. On the Malecón, the loss of plant and animal species was significant, accompanied by a noticeable decrease in ecological connectivity. These processes were exacerbated by sea level rise, heavy rainfall, and changes in weather patterns, which accentuated the vulnerability of the coastal ecosystem (figure 4).

**Figure 4.** Visualization of the deficit of green areas in the Malecón sector

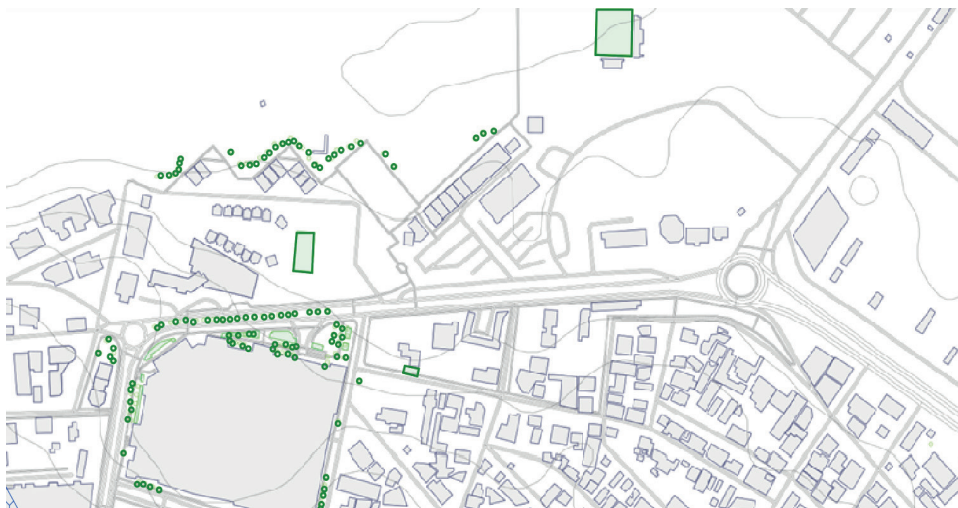
In sectors such as Playa Murciélago, records showed vegetated areas that did not exceed the minimum required per inhabitant, with conditions that hindered both physical accessibility and ecological connectivity. This compromised the mobility of wildlife and citizens, directly affecting the biodiversity and recreational functionality of the space (figure 5).

**Figure 5.** Visualization of the green space deficit in the Playa Murciélago sector
