Analysis and proposals for an inclusive classroom block

Introduction: the study addressed universal accessibility in the San Damian University Medium (MUSD) of CESMAG University, in order to identify architectural barriers affecting people with visual, hearing and reduced mobility disabilities. The research started from the need to guarantee inclusion in educational spaces, considering the Colombian regulation NTC 6304 and the principles of universal design.

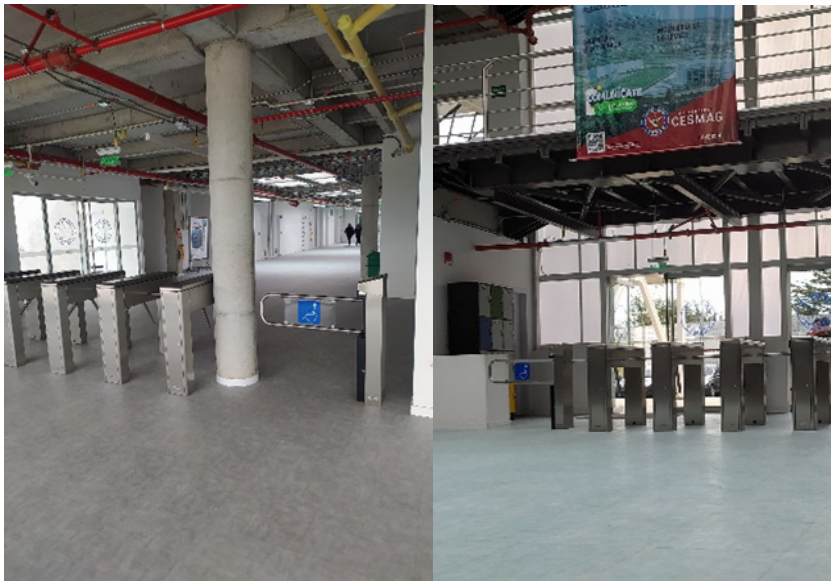
Figure 3. Main entrance and rear entrance to the MUSD-CESMAG classroom block

The MUSD has two main entrances: one for pedestrians and one for vehicles. The entrance to the educational establishment has deficiencies that affect its accessibility. And although the surface area designated for horizontal circulation partially complies with standards, as it is firm and non-slip, it also lacks tactile tiles or plates to facilitate the movement of people with visual impairments.

For people with reduced mobility, there is at least one accessible entrance for priority use with a minimum clear width of one meter. However, among the main problems identified are the lack of pedestrian crossings on the roads immediately adjacent to the campus, the absence of ramps or crossings on the sidewalks that allow adequate access for wheelchair users, and the location of the public transport stop on a steep slope, which makes it difficult for people with reduced mobility to use. Similarly, the parking bay is difficult for this group to access. The parking lot has only one space marked for people with disabilities.

There are routes that are interrupted by ramps that do not provide much safety for wheelchair users, such as the main access from the road to the interior of the facilities and some uneven platforms in the parking area. Although these may seem like minor obstacles at first glance, they cause discomfort and a sudden fall when descending. They also create further complications with the door installed, where it is difficult to move without assistance. For example, the glass doors connecting the administrative area to the main court are heavy and require pushing to open. In addition, they have pressure bars, which can make it difficult for people with reduced mobility to open them. This could prevent some people from moving independently to enter or exit the building.

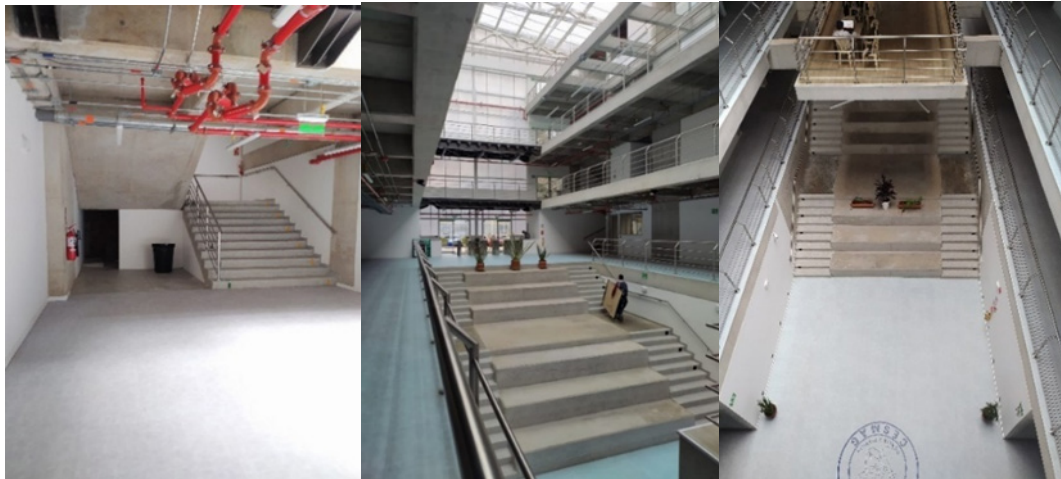
The design of the corridors takes into account not only the normal flow of people, but also the maneuvering, turning, and direction-changing needs of people in wheelchairs. The corridors are free of obstacles, ensuring accessibility along the route. There are no protruding elements, and it complies with the requirements established to guarantee mobility without difficulties. The floor has a 5 cm concrete finish, hardened, polished, and glazed in white. The floor coverings are firm and non-slip in both dry and wet conditions, ensuring safe transit in the space. In addition, both the floor and wall surfaces are designed to prevent slipping.

Figure 6. Facilities inside the MUSD-CESMAG classroom block

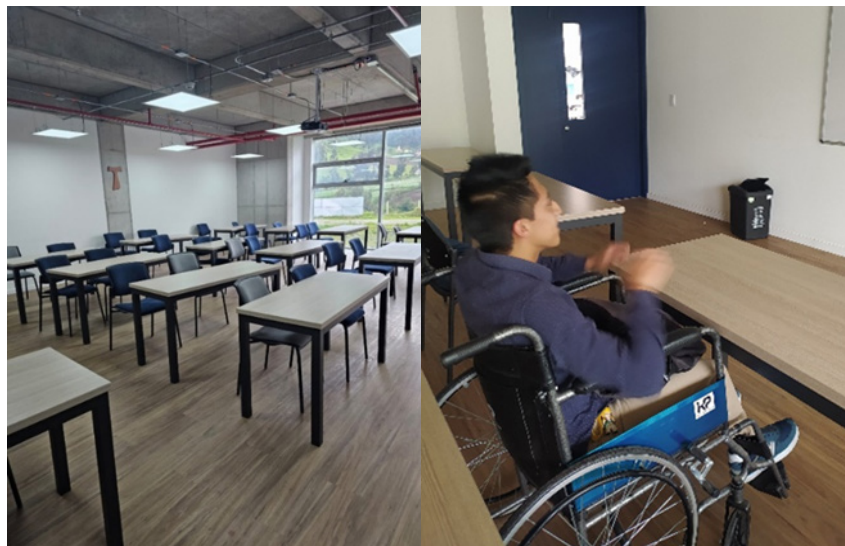
Specifically, according to the original floor plan, the classrooms include spaces designated for people with reduced mobility. None of these provisions have been implemented in the execution, as none of the classrooms have adequate furniture for people with functional diversity. In addition, the Braille signage that should indicate the classroom number is absent, making it difficult for them to find their way around the building independently. This lack of accessibility creates a significant barrier to the inclusion of people with disabilities.

Figure 7. Classrooms at San Damián University Center - CESMAG

The classrooms, especially the larger ones, have an echo problem that affects the acoustics of the space, which is a challenge for people with hearing disabilities. To solve this problem, the installation of sound amplification systems, such as microphones or speakers, should be considered. Additionally, the incorporation of visual support technology, such as electronic devices or home automation systems, could be of great help in improving class comprehension. These technological solutions would offer an alternative for students with hearing difficulties, allowing them a more inclusive and accessible educational experience. It is essential that classroom design and support systems comply with regulatory requirements and effectively respond to the needs of all students, ensuring their autonomy and full participation in the educational process.

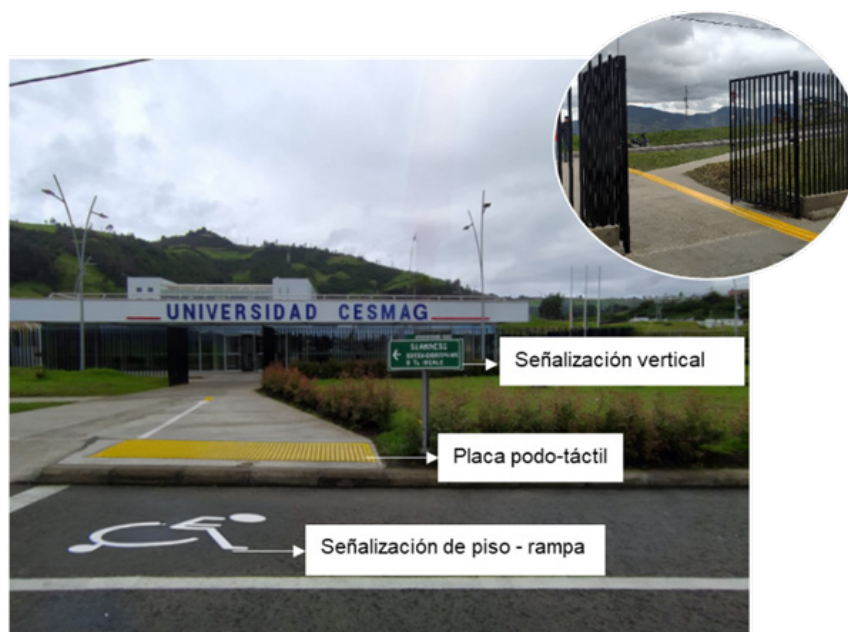
Figure 8. Accessible imagery at the entrance to the MUSD-CESMAG administrative block

Another practical solution to improve accessibility in the classroom block and its adjacent routes is the implementation of tactile paving tiles, which can be either guide or warning tiles, designed specifically for people with visual impairments. Integrated tactile paving tiles are designed as complete tiles that incorporate specific patterns: guidance (with stripes) and warning (with dots). They include four stripes or 36 raised dots, which optimize installation and ensure clear, tactile orientation.

Their polycarbonate or stainless steel material ensures greater wear resistance and an aesthetic appearance that blends in with the design of the environment. The tiles can be adhered to the floor using specialized glue or installed with pin embedding systems, which simplifies their implementation and guarantees a long service life with low maintenance.

The installation of tactile paving tiles is an efficient and normatively supported measure to transform the block into a more accessible environment. Its implementation not only responds to the orientation and safety needs of people with visual impairments, but also reinforces the institutional commitment to inclusive and universal design. This intervention, although simple, has a significant impact on the quality of life and autonomy of users.

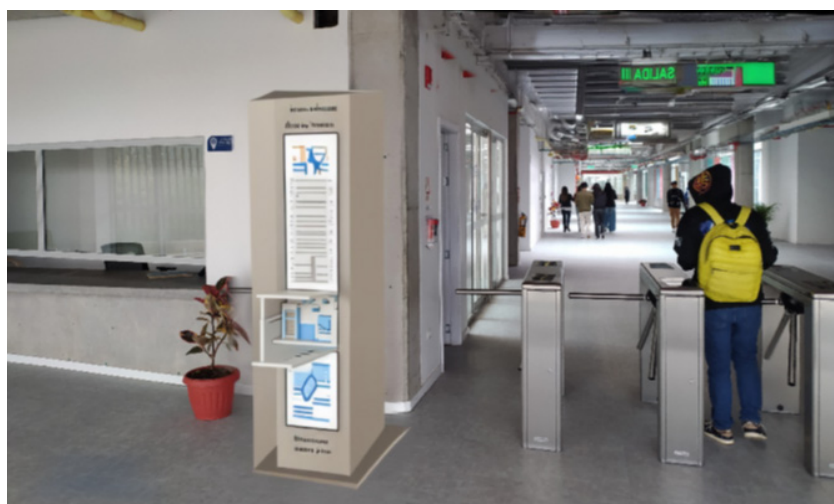
Figure 9. Proposed itinerary location and haptic map

A standard information point equipped with a tactile map is required, accompanied by information written in Braille to facilitate spatial understanding and the location of different areas of the campus through touch. Advanced technology can be incorporated, such as an interactive screen offering access to institutional information, complemented by headphones that provide audible instructions, allowing people with visual impairments to hear relevant information. This option could include additional features such as itinerary notices and interactive elements for consulting schedules and specific locations. Proposals must comply with ergonomic measures that are inclusive, i.e., if a person with reduced mobility approaches, they must be able to access it as easily as any other user.

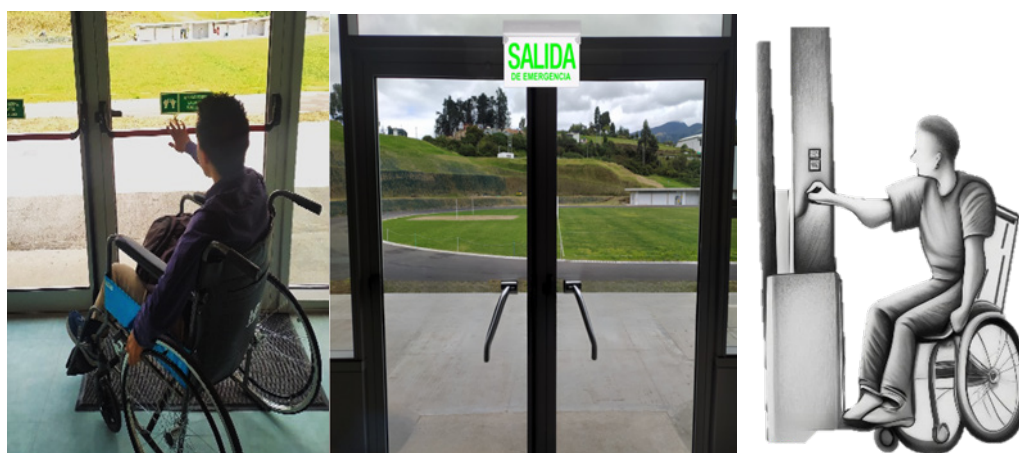
Figure 10. Existing doors and proposed accessible door at MUSD-CESMAG

On the other hand, for emergency exits and evacuation routes to be truly effective, doors must be accessible to all types of users and must be able to be opened with minimal effort. Automatic sliding doors or servo-operated swing doors may be used for this purpose. These doors have a detection device that prevents people from coming into contact with them during opening and closing, and a delayed return mechanism that allows safe passage and detects the presence of people in the closing area. In the event of a power failure, they can be operated manually.

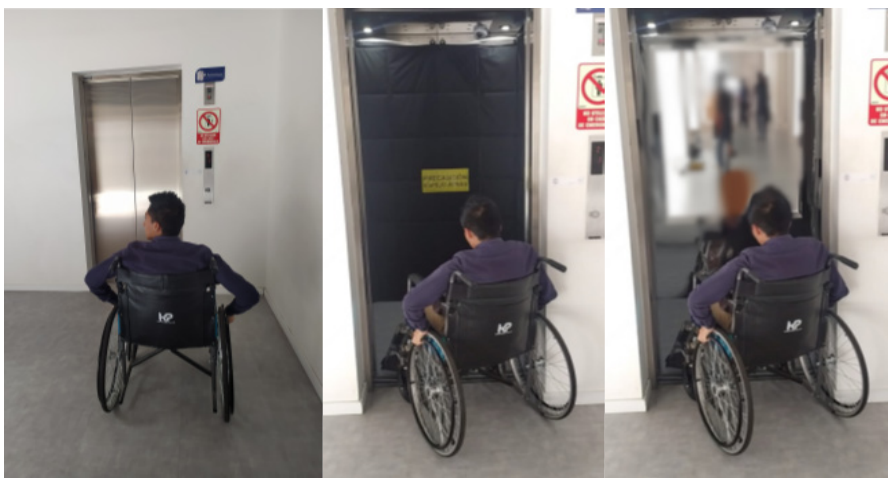
One of the problems identified in the MUSD classroom block is related to the functional conditions of the elevator. Although the equipment has elements required by accessibility regulations, such as the installation of a mirror to facilitate the visibility of obstacles when reversing out of the cabin, and a side support bar to ensure stability during movement, it was evident that these elements are sometimes covered by tarpaulins or other materials, which limits their effective functionality and contravenes the principles of universal accessibility.

Regarding the elevator's capacity to absorb pedestrian traffic demand at times of high traffic, it was determined that the exclusivity of a single functional elevator represents an operational risk, since, in the event of a failure, people with reduced mobility would be left without a viable alternative for vertical circulation. This situation highlights the need to implement complementary measures for assisted horizontal or vertical transportation, as well as to establish priority protocols for elevator use by persons with disabilities. The installation of evacuation chairs at visible and strategic points within the University is recommended. These chairs should be easily operable and allow for the safe transport of persons with reduced mobility via stairs and other evacuation routes.

Figure 11. Classroom block elevator

In terms of the sensory communication system, the elevator provides adequate and understandable audio responses for people with visual impairments. However, it is suggested that the waiting time for the automatic closing of doors be optimized in order to facilitate safe and unhurried entry for people with reduced mobility.

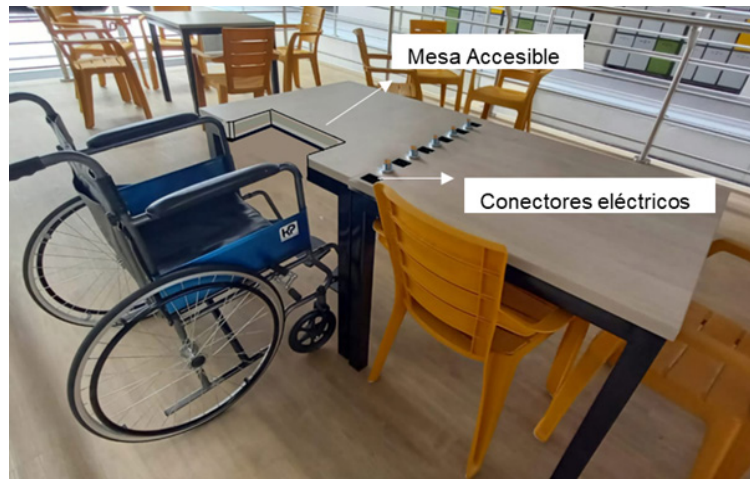
Figure 12. Imaginary images in the study areas of the San Damián University Center

In the study room areas, where power outlets are currently located on the floor, it is essential to improve accessibility by installing outlets at desk height. This will allow people with reduced mobility or visual impairments to access them more easily and independently. In addition, it is recommended to ensure that at least one workstation has accessible ergonomic furniture, which ensures sufficient space for wheelchair maneuverability and the integration of tactile or Braille signage for easy identification.

To improve orientation for people with visual impairments in the classroom block, we propose the implementation of Braille signage on stair handrails. This signage, located at the beginning or end of the handrail, would indicate the floor number in Braille. Other relevant information could also be included in the signage, such as the location of classrooms or services on that floor, to facilitate orientation and independent mobility.
